Evaluation of a 406 MHz Emergency Locator Transmitter (ELT)

Prepared for
Transportation Development Centre
Transport Canada

MARCH 2001

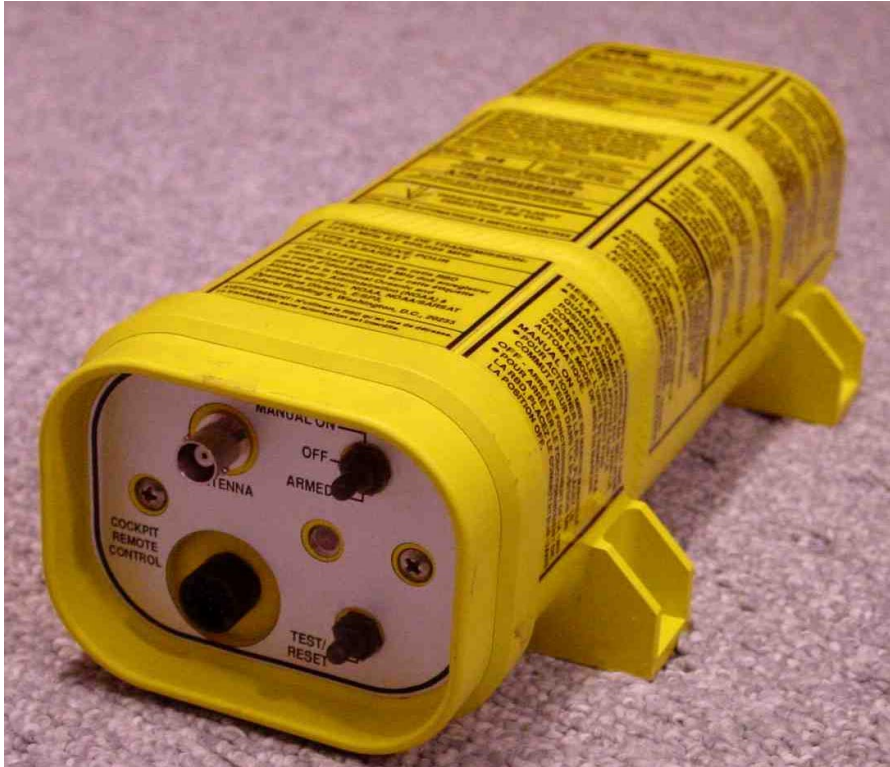
Figure 1: NAT SATFIND-406 ELT A-1000

The equipment used for the evaluation project were the Northern Airborne Technology SATFIND-406 ELT Models A-1000 (Figure 1) and A-1500 (Figure 2) connected to a Comant CI319-1 High Speed Triple Frequency antenna (Figure 3). Arrangements were made with Kelowna Flightcraft Ltd. of Kelowna, B.C., to install the equipment on a Purolator BOEING 727 aircraft. The original intent was to install the ELT in the tail of the aircraft, install the cockpit monitor and control unit in the cockpit, and mount the antenna on one side of the fuselage between the rear starboard engine and the vertical member of the tail structure. Unfortunately, completing the installation in this manner would have required a Supplementary Type Certificate (STC). Obtaining an STC would have been an expensive and time-consuming exercise and was beyond the scope of this project. As a result, an alternative mounting technique was required.

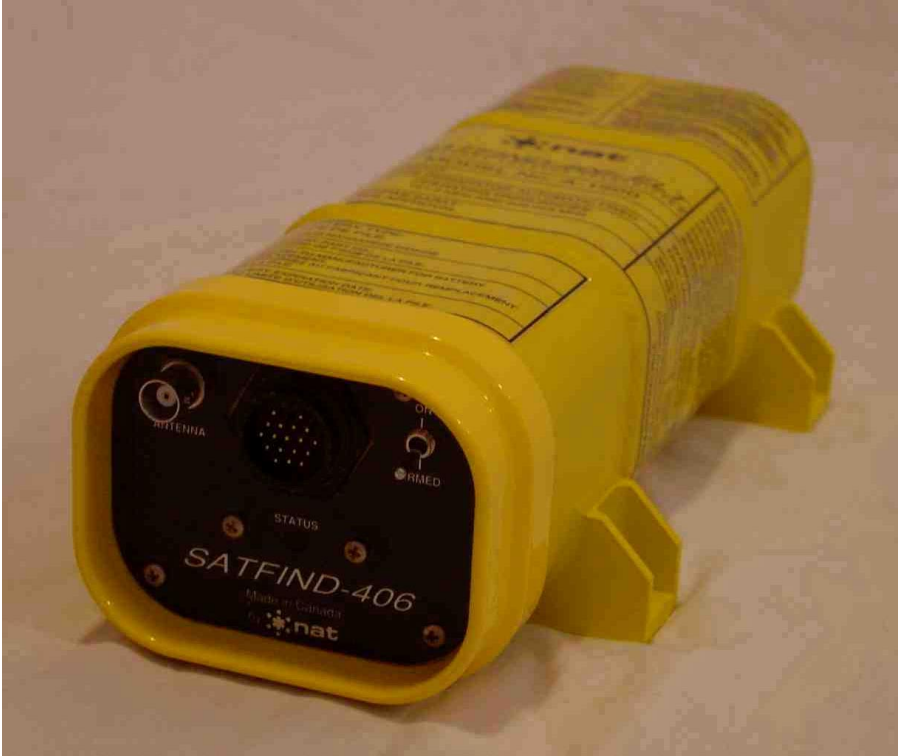
Figure 2: NAT SATFIND-406 ELT A-1500

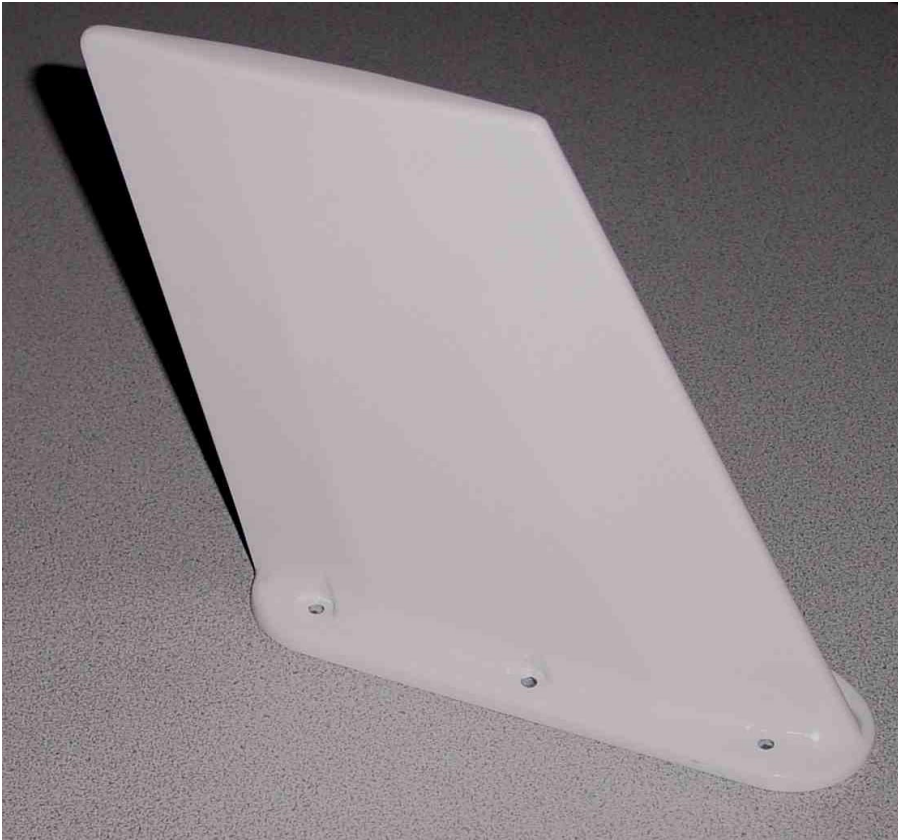
Figure 3: Comant CI319-1 High Speed Antenna

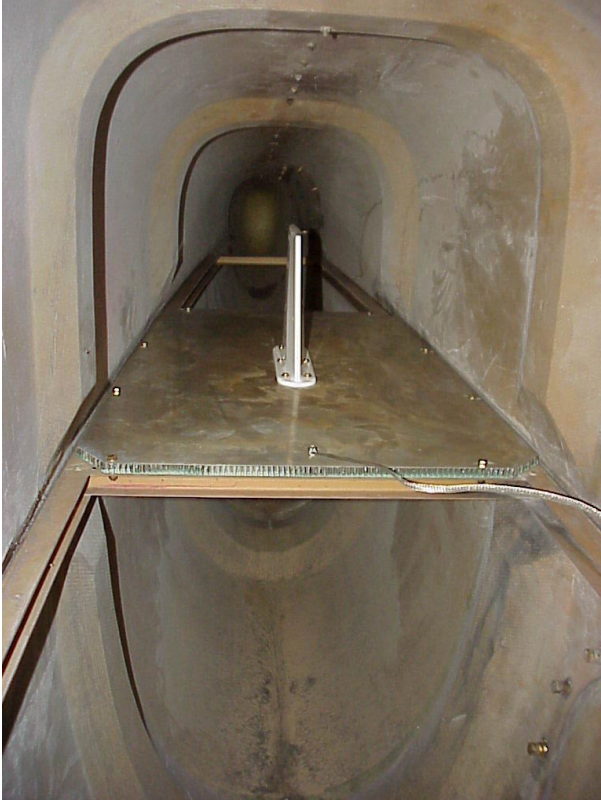
Figure 4: Antenna Mounted on Ground Plane Inside Tail Cone

Another suggested approach was to mount the antenna on a suitable ground plane, which would then be installed in the tail cone situated at the top of the T-tail between the horizontal stabilizers, as shown in Figures 4 and 5. The advantage of this was that the skin of the aircraft was not pierced. Also, with the antenna mounted inside the tail cone, it would not be subjected to the concentrated airflow patterns that exist in the vicinity of the tail structure and engines. Although a high-speed, triple-frequency antenna was used in this evaluation, a less expensive, low-speed antenna could have been used. Another important advantage of this installation method was that the antenna had a much clearer view of the sky when mounted in the tail cone. This would increase the probability of a successful emergency transmission to the satellites after a crash situation.

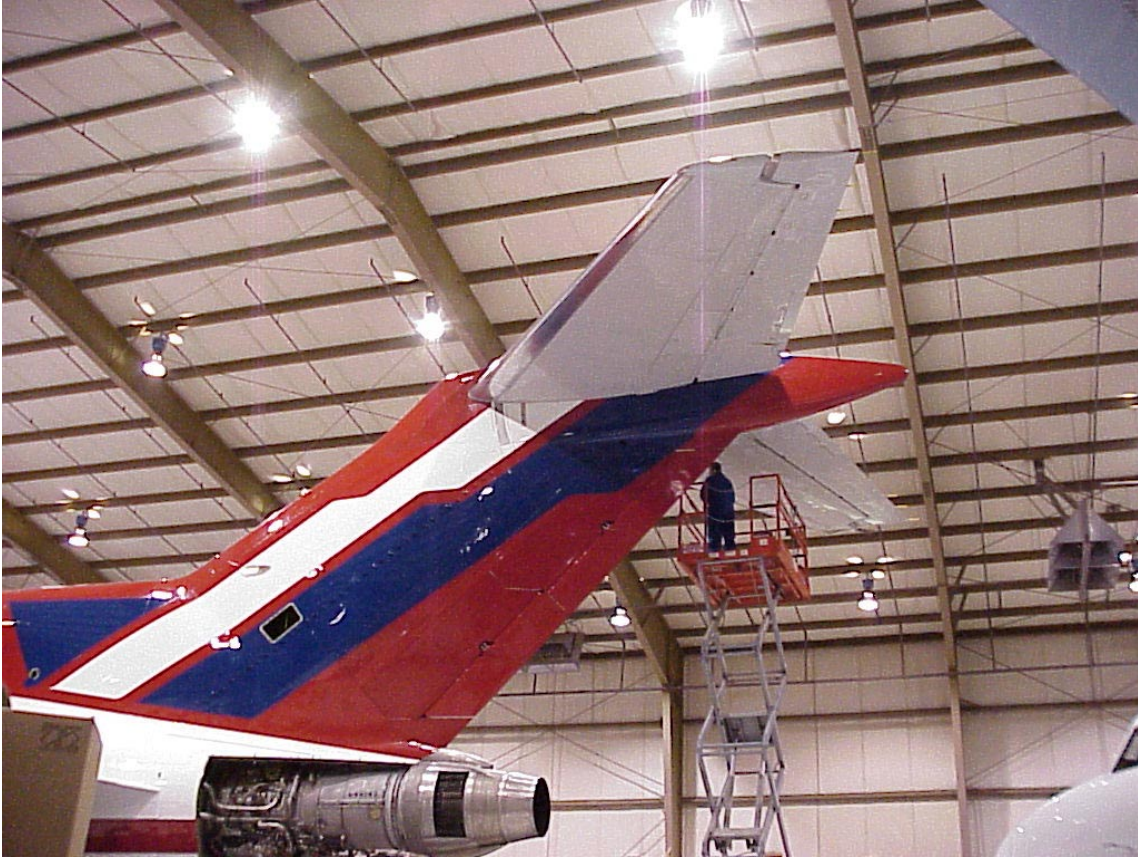
Figure 5: Tail Section of Boeing 727
